Safety at Girton Corner

Summary Statement

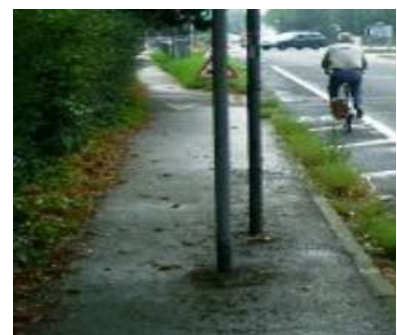
From Girton College entrance to a point some 40m before Girton Corner there is a shared-use pavement, in which are embedded two posts, one now entirely redundant and acting only as a hazard to those using the pavement.

We recommend **that the redundant post in the shared-use path be removed.**

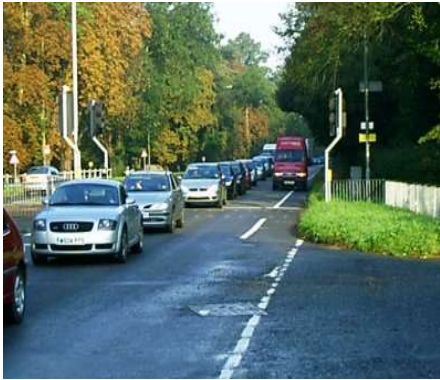
From north of the A14 bridge there is a southbound bus lane along Huntingdon Road. This terminates about 100m before Girton Corner, allowing vehicular traffic to travel in two lanes, although some 40m before the junction a (mandatory) cycle lane suddenly appears as cyclists are directed off the shared-use pavement onto the road.

This cycle lane is 1.15m wide, significantly less than the DfT recommended 1.5m *minimum*⁶ and the access to the road demands an awkward manoeuvre for a cyclist.

At this point the road is artificially narrowed on the offside by painted hatching, pushing motor vehicles and cycles into greater potential conflict. A driver who passes this point just as a cyclist arrives may be completely unaware that the cyclist

is now on the road beside him/her.

We recommend **that the cycle lane from Girton College be merged with the road at the point where the bus lane ceases, with an illuminated KEEP LEFT bollard to protect cyclists; that the cycle access to the road be made more smooth than the present double-right-angle; and that south of this the pavement be no longer shared-use. That the cycle lane be made to the DfT recommended width of 2m from here to at least the Thornton Road junction (beyond which Huntingdon Road narrows). Any hatching necessary to preserve the narrowness of the motor traffic lane should be on the nearside, between that lane and the cycle lane. That the northbound cycle lane also be upgraded to 2m.**

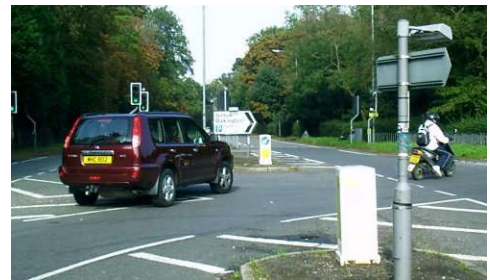
The direction sign on the central island at Girton Corner is in such a position that it obscures the view. This is apparently a deliberate ploy by traffic engineers, intended to slow traffic down. In practice it does not achieve this goal, but merely causes a blind spot which particularly endangers cyclists, and motorists turning right into Girton. We cannot believe that the deliberate creation of dangerous situations, in the hope that motorists will respond by reducing their speed, can be conducive to overall safety.

We recommend **that the direction sign on the central island at Girton Corner be raised to a height where it will not restrict visibility for any road user.**

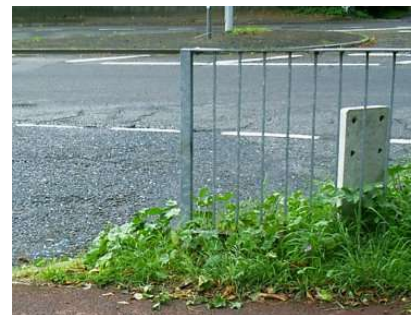
From the pedestrian crossing southwards to Girton Corner on the southbound side there is a length of visirail which extends to the very edge of the kerb. This ensures that if there is a cycle-vehicle conflict here the cyclist has no possibility of escape. The railing appears to serve no useful purpose, since very few pedestrians using the crossing from east to west will come from positions where they might be tempted to 'jump the light' by crossing south of them.

We recommend **that the railings to the kerb on the north of Girton Corner be removed.**

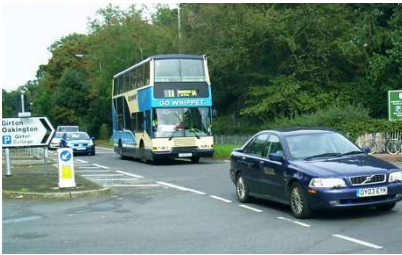
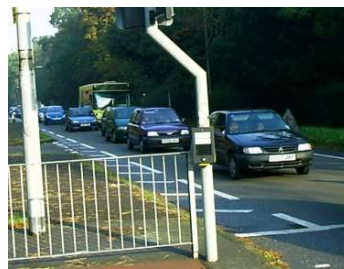
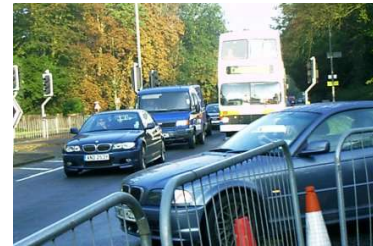
The fatal accident at Girton Corner last year was the result of a collision between a south-bound cyclist and a left-turning vehicle. Although the case is still *sub judice*, it is clear that it is too easy for motor vehicles, particularly large lorries and artics, to cut the sharp corner very closely.

We recommend that hatchings be added on the shoulder of the north access to Girton Road to encourage vehicles to take the corner as wide as possible.

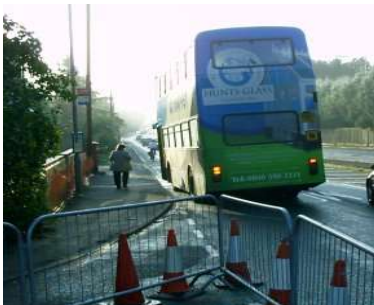
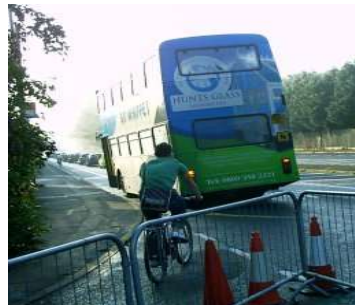
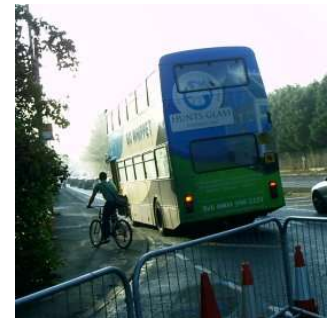
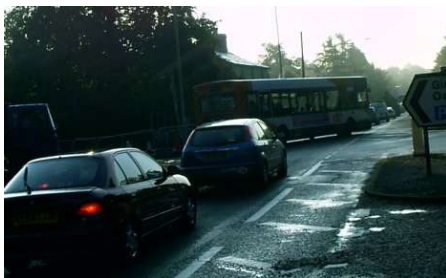
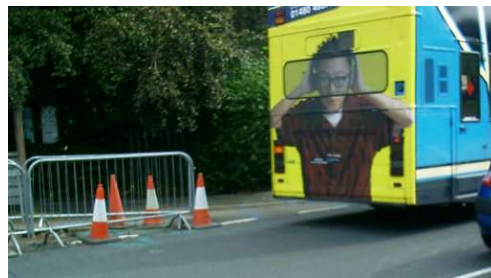
There is a bus stop (though no road marking) immediately to the south of Girton Corner: motorists who expect a bus to stop here will routinely overtake before Girton Corner. Buses typically stop with the bus tail only a metre or so beyond the point at which the Girton Road cycle lane is planned to meet the cycle lane on Huntingdon Road. Thus any cyclist entering Huntingdon Road from Girton Road is immediately put into a position of conflict with southbound vehicular traffic, or in danger of being pushed into the kerb by a stopping bus.

We recommend that the bus stop immediately south of Girton Road be moved southwards to the next lamp post, and a bus stop be marked on the road⁷.
